April 4, 2024

Re: Promontory Point Condition Study
5491 S DuSable Lake Shore Drive
Chicago, IL 60615

Executive Summary

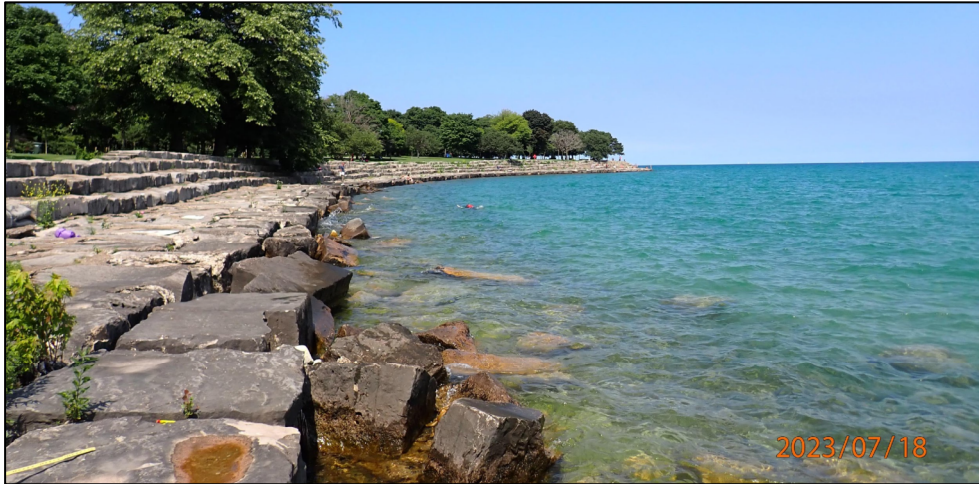
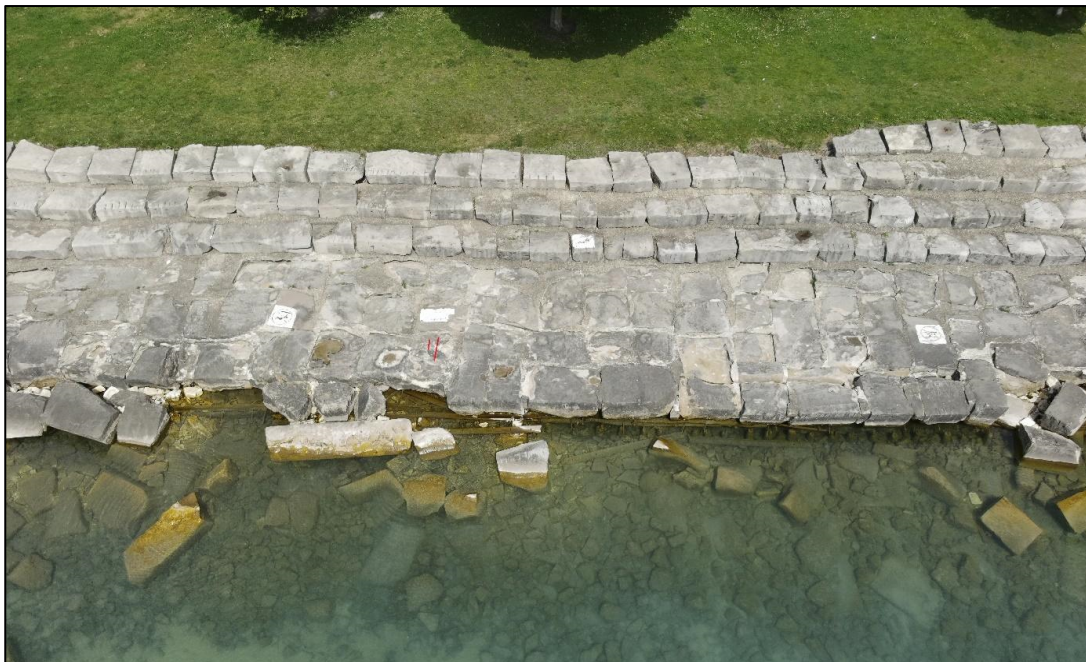
Figure 5.1. Terrestrial View of S1

Figure 5.2. Aerial View of S1

The overall Condition Assessment Rating of Section S1 is **Satisfactory**. Ratings by component are shown below in **Table 5.1**, and described in further detail below. Inspection photos of each component in this section are provided in Appendix C.

The revetment is in overall satisfactory condition. As a result of its sheltered position, the stepped courses of S1's revetment typically exhibit good alignment and overall condition compared to other sections of the structure. There are isolated voids between limestone blocks that McLaren recommends filling with cementitious grout. Additionally, at several locations along the revetment, there are voids between the first (lowest) course and the promenade that exhibit complete penetration through the limestone structure into the water below.

The earthen fill behind and beneath the revetment is typically intact. In several locations, however, McLaren was able to probe voids in the revetment, discovering isolated areas that exhibited complete loss of subgrade material. This condition can be addressed through maintenance. Installation of drainage systems and pressure injected grout will provide stabilization of the blocks and arresting of fill loss.

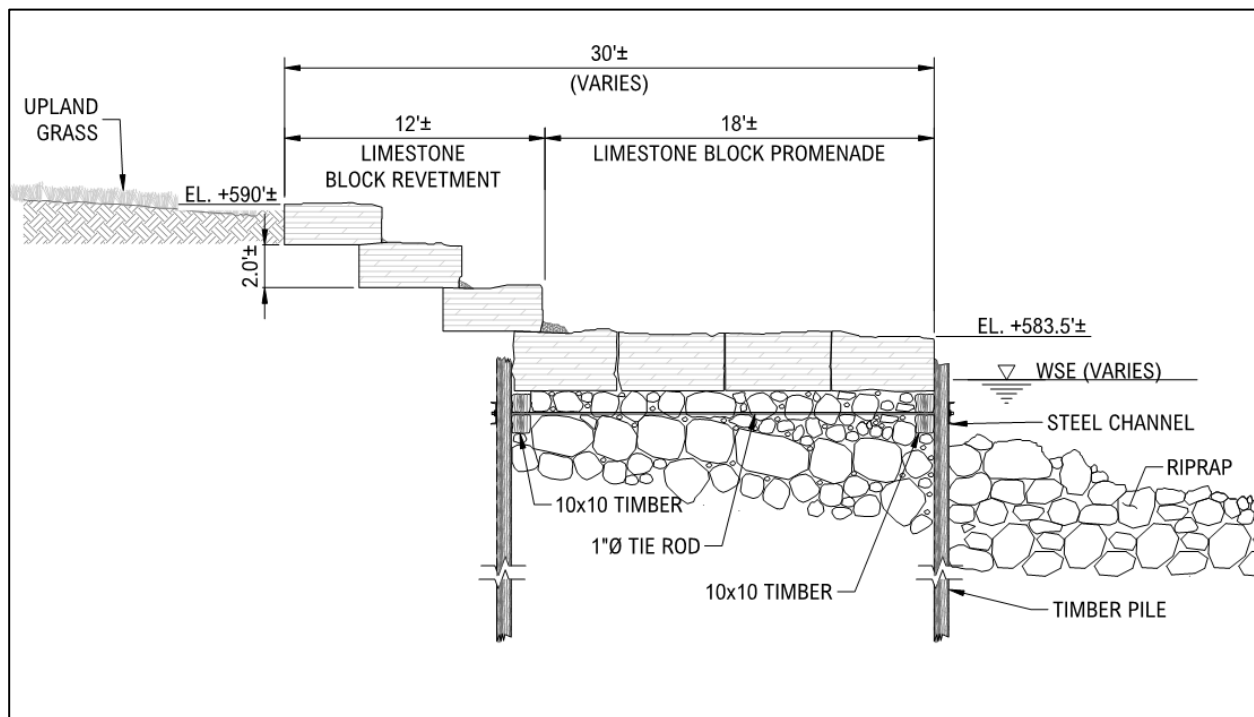
Figure 5.3. Typical Cross-Section of Section 1

Immediately offshore of the promenade, a row of timber piles supports the remains of a derelict cribbing system, including a failed steel waler and failed steel tieback rods. The offshore edge of Section S1 generally faces east to southeast and is sheltered against most wave action. This is reflected by the generally intact condition of the promenade. A typical view of the cross-section is provided below in **Figure 5.3**.

The timber cribbing system is in serious condition and exhibiting localized failures. The steel waler and steel tieback rods are largely derelict. However, this steel tieback system was required only for construction and is not necessary for future maintenance. Typically, the eight-inch diameter timber piles immediately offshore of the promenade are in good condition, exhibiting no signs of widespread fungal or mechanical damage. Although the waler and tieback system is no longer functional, the remaining timber piles act to retain larger stone fill and could be a useful component for restoration, acting as an edge-bearing point and a modified retaining structure.

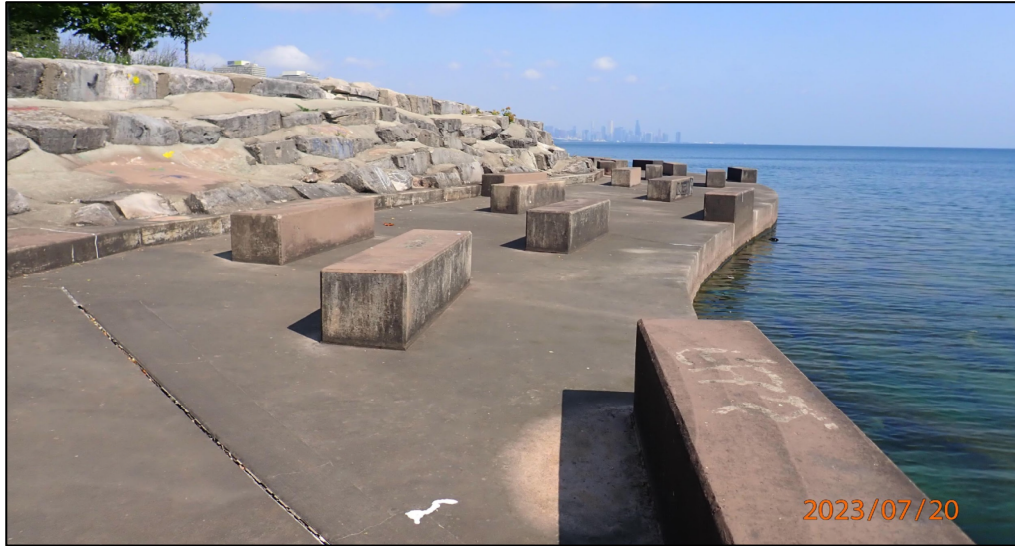
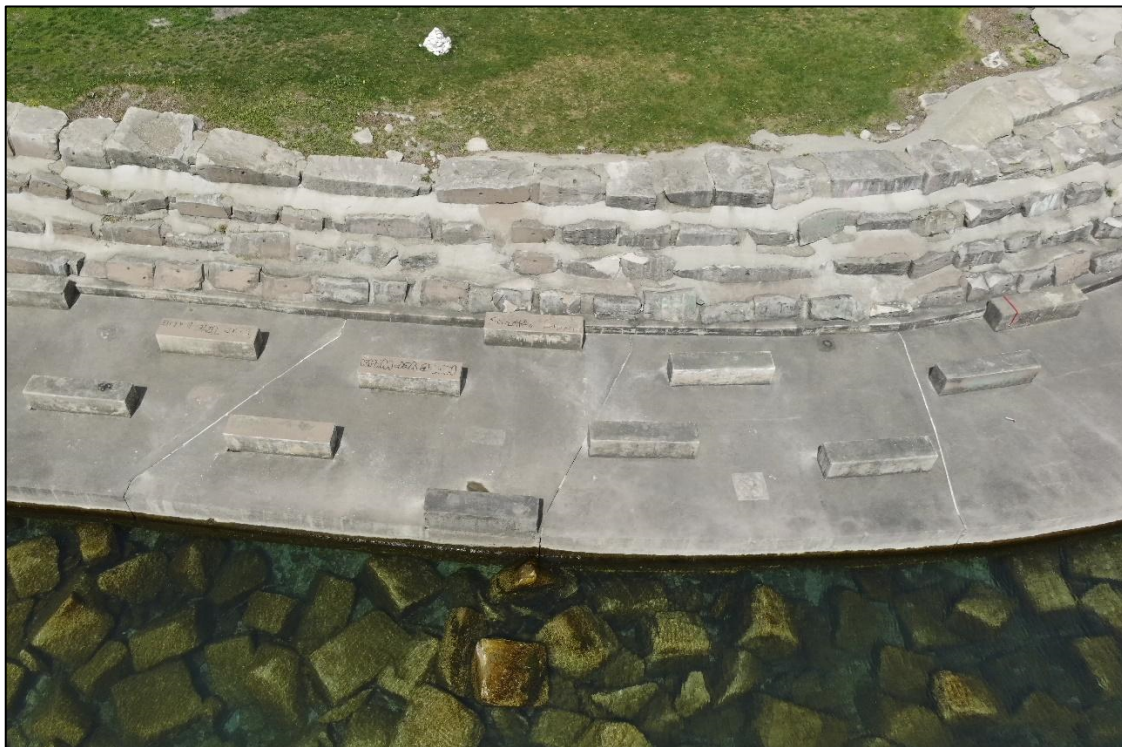
Figure 5.4. Terrestrial View of S2

Figure 5.5. Aerial View of S2

The overall Condition Assessment Rating of S2 is **Satisfactory**. Ratings by component are shown below in **Table 5.2** and further described below. Inspection photos of each component in this section are provided in Appendix C.

The upland fill is in overall poor condition. Significant erosion damage is present due to overtopping waves and poor drainage, which results in a loss of fill behind the revetment on the park-side. Notably, this poor condition is not the result of the failure of the revetment to provide adequate storm damage and shoreline protection. Rather, it stems from lack of maintenance and failure to provide adequate protection of and draining from the upland during overtopping events. The loss of grass and earthen fill extends as far as twenty (20) feet inshore of the revetment in the worst-affected regions, including a large region of erosion present between STA 16+10 and STA 16+50. Notably, this deterioration appears to be associated with the settling of a portion of the revetment in the same location. Evidence of overtopping waves was also observed in the concrete step revetment north of the Point, so this appears to be a common problem along the entire lakefront and not unique to the Point.

Specific areas of concern include areas of settlement within the revetment observed at stations 15+00, 17+10, and 17+60. The most significant of these deficiencies is the portion of S2 between STA 16+10 and STA 16+50, where the revetment has partially collapsed. The upland area above the affected area exhibits significant erosion, with areas of voiding, suggesting the loss of subgrade material may be due to inadequate drainage in the upland area.

McLaren is currently evaluating options for providing proper drainage for overtopping waves at the site, which will protect the Point from further damage of this nature. These design options will be presented in our forthcoming **Alternative Design Study**.

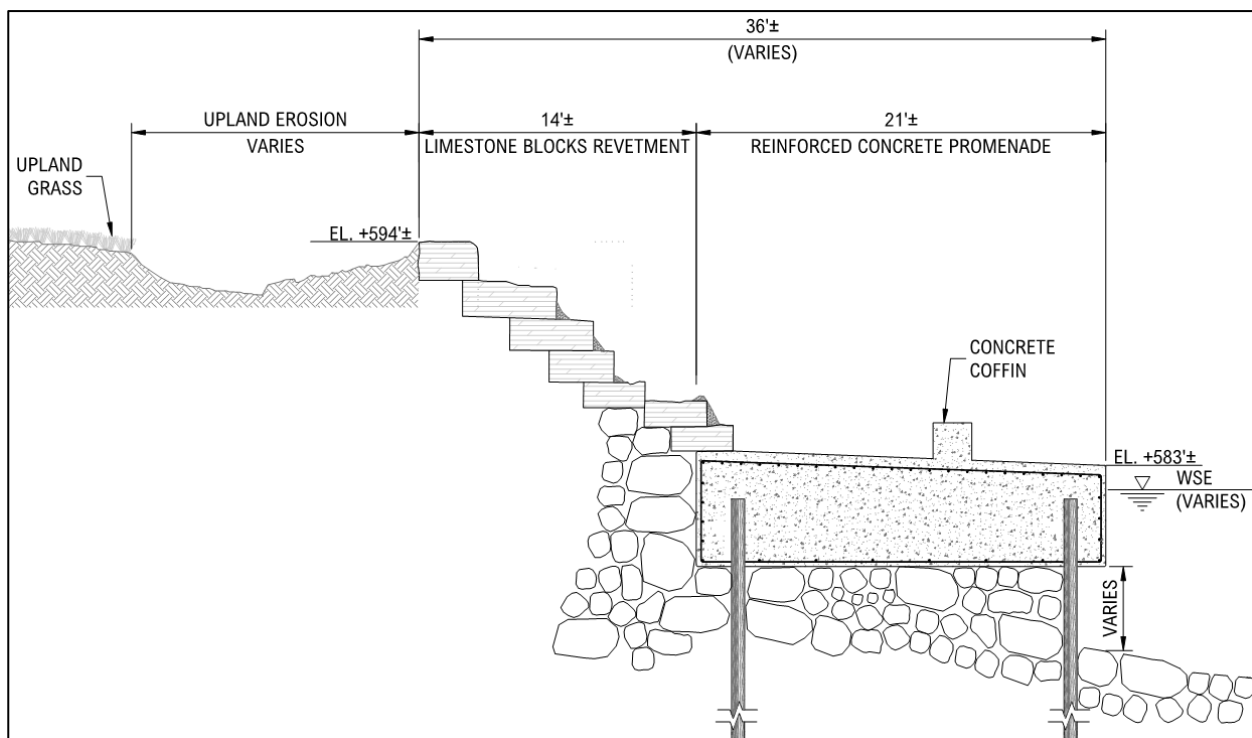
Figure 5.6. Typical Cross-Section View of S2

Unique to section S2, the timber piles of the cribbing system are not offshore of the promenade. Instead, the outer edge of the concrete platform itself sits on the piles. A typical view of the cross-section is provided below in **Figure 5.6**.

The promenade subgrade is in overall poor condition. Due to wave action, the fill material below the promenade has eroded out from beneath it, resulting in widespread voiding. However, the promenade exhibits no sign of imminent failure due to the structural support provided by the timber cribbing system. Restorative efforts should reestablish the promenade subgrade for redundant support and protection of the fill below the revetment.

The typically eight-inch diameter piles are in overall good condition, exhibiting no signs of widespread fungal or mechanical damage. The steel waler and steel tieback rods were abandoned in 1960 and are no longer required. Long term maintenance in this segment should consider the protection and strengthening of the timber piles while restoring the fill beneath the promenade and areas of the revetment which have been undermined.

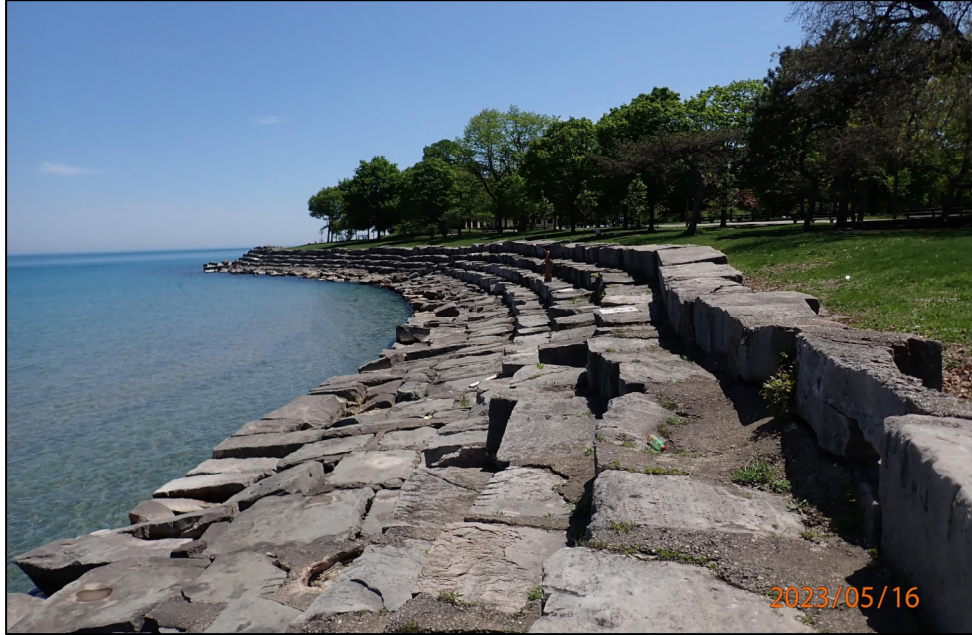
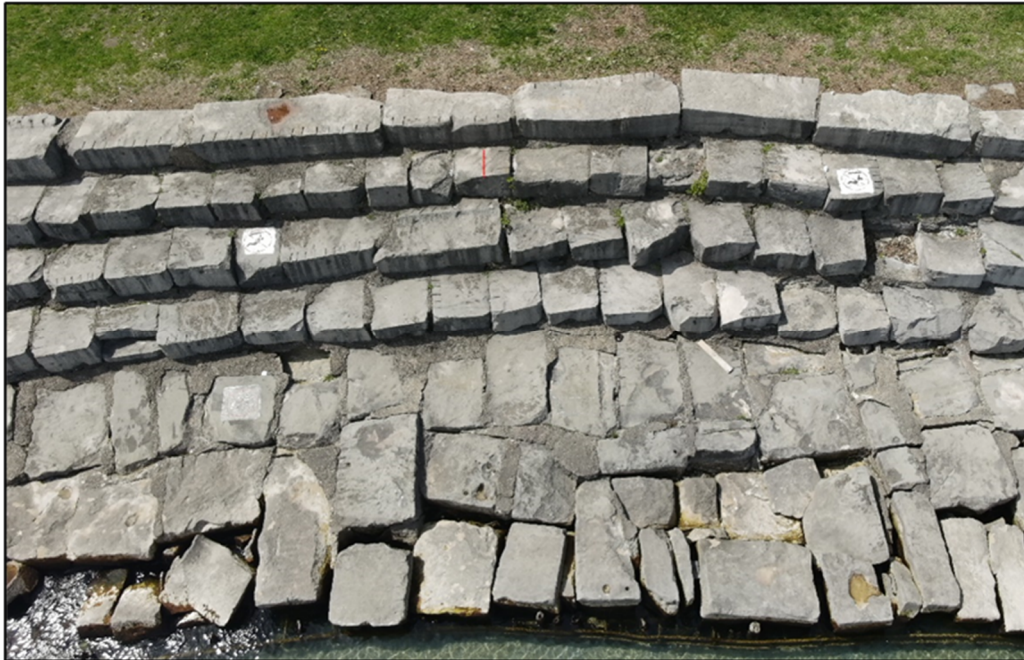
Figure 5.7. Terrestrial View of S3

Figure 5.8. Aerial View of S3

The overall Condition Assessment Rating of S3 is **Poor**. Ratings by component are shown below in **Table 5.3** and further described below. Inspection photos of each component in this section are provided in Appendix C.

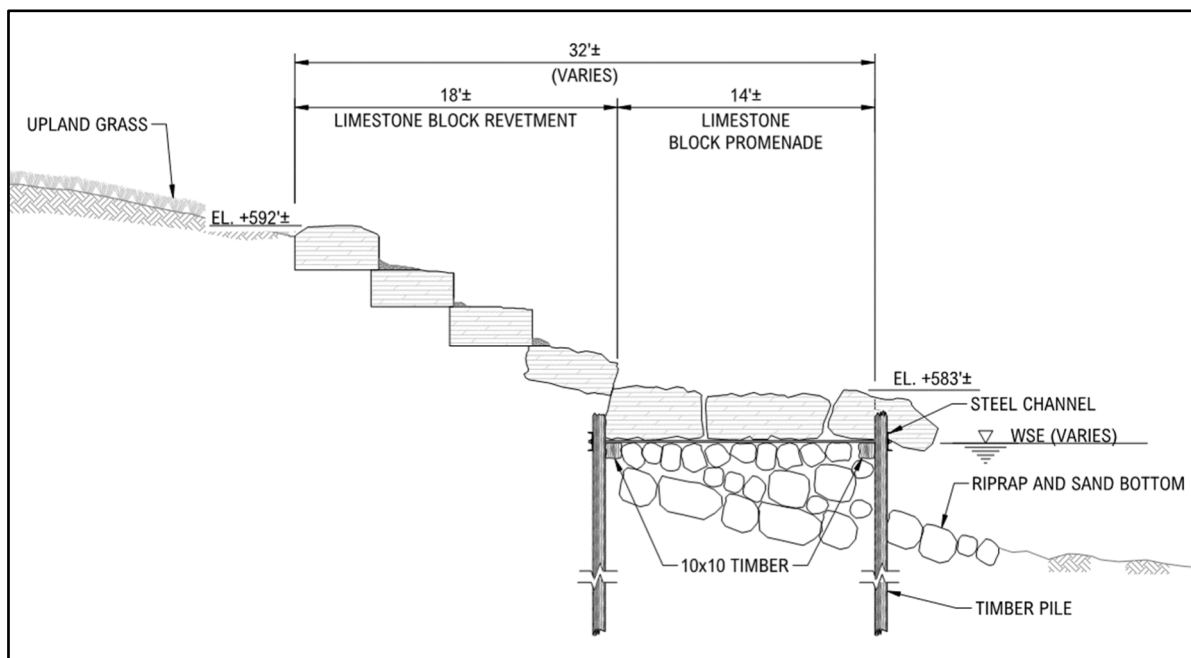
Figure 5.9. Typical Cross-Section of Section 3

Section S3 is exposed to aggressive wave action from the northeast, resulting in significant undermining beneath the promenade and further upland erosion due to overtopping waves. This loss of fill material has led to widespread, intermittent collapse in both the revetment and the promenade. S3 exhibits the most widespread and significant damage observed at the entire site. A typical cross section of Section 3 is provided below as **Figure 5.9**.

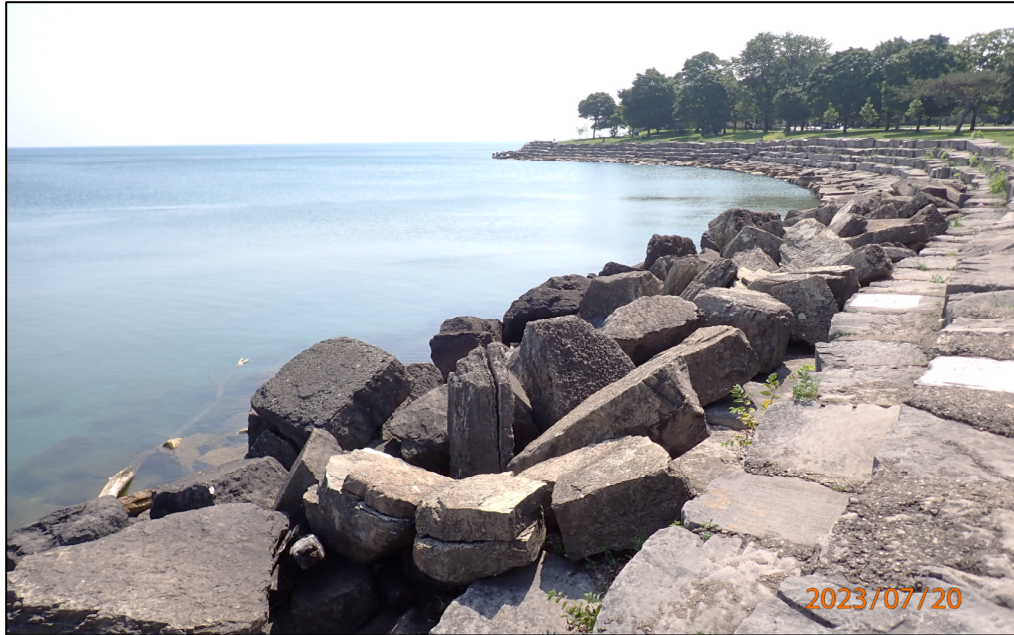
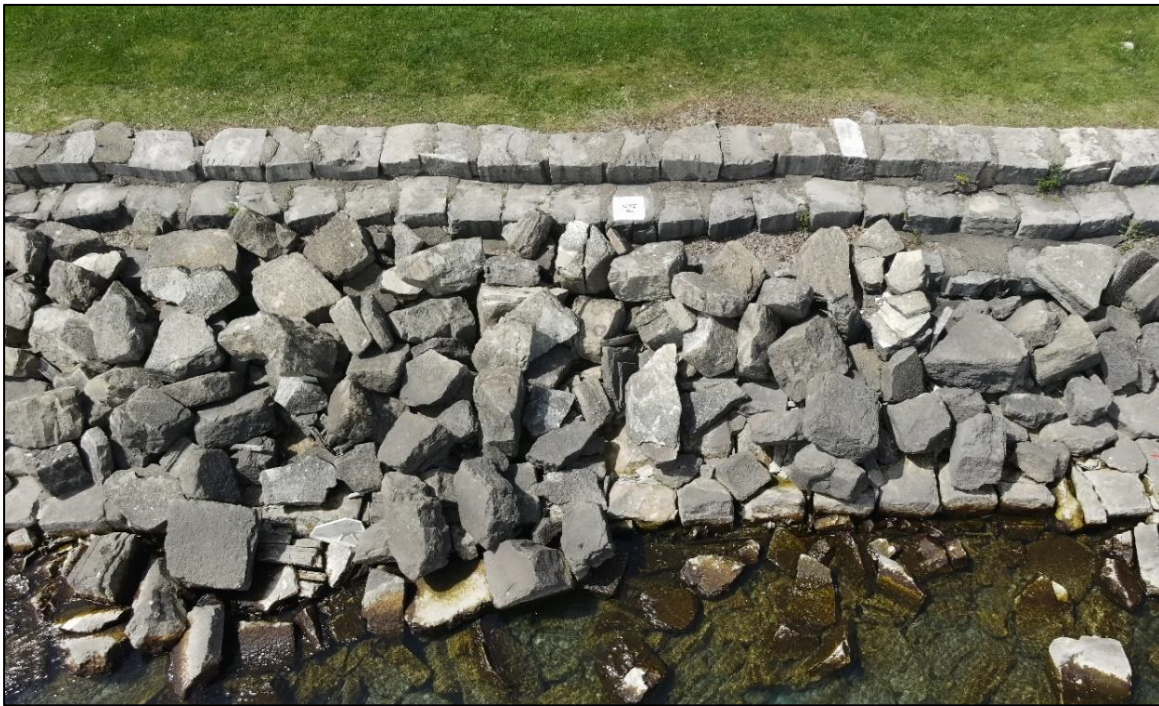
Figure 5.10. Terrestrial View of S4

Figure 5.11. Aerial View of S4

S4 is generally in satisfactory condition and exhibits no significant deterioration. There is minor erosion present in the upland fill that may require additional drainage. The riprap promenade found here does not conform to the original, historic design of a stepped, limestone revetment down to a limestone promenade, having at some point replaced the initial structure after construction. This riprap promenade does not provide a universally accessible walkway to pedestrian visitors, an issue that should be re-visited, however, from a purely structural perspective, there are no indications that restorative efforts are required at S4.

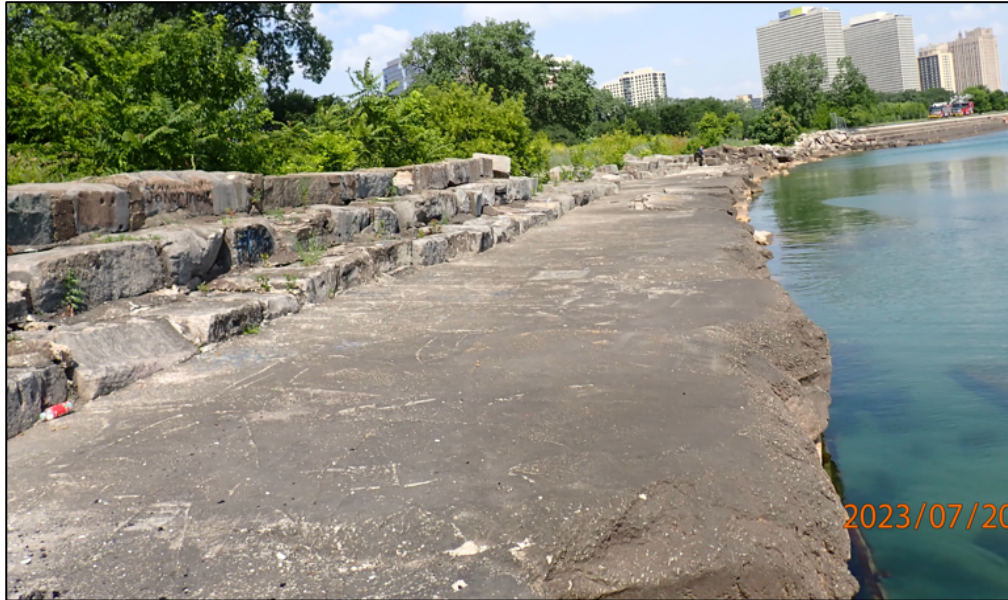
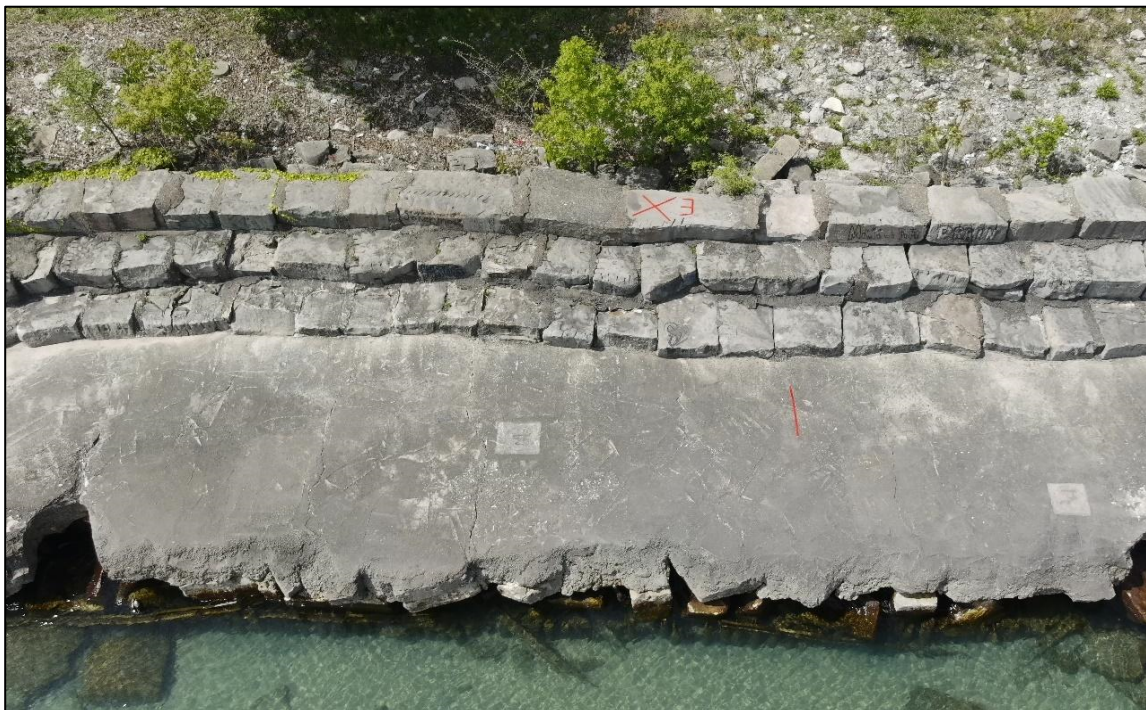
Figure 5.13. Terrestrial View of S5

Figure 5.14. Aerial View of S5

The overall Condition Assessment Rating of S5 is **Fair**. Ratings by component are shown below in **Table 5.5** and further described below. Inspection photos of each component in this section are provided in Appendix C.

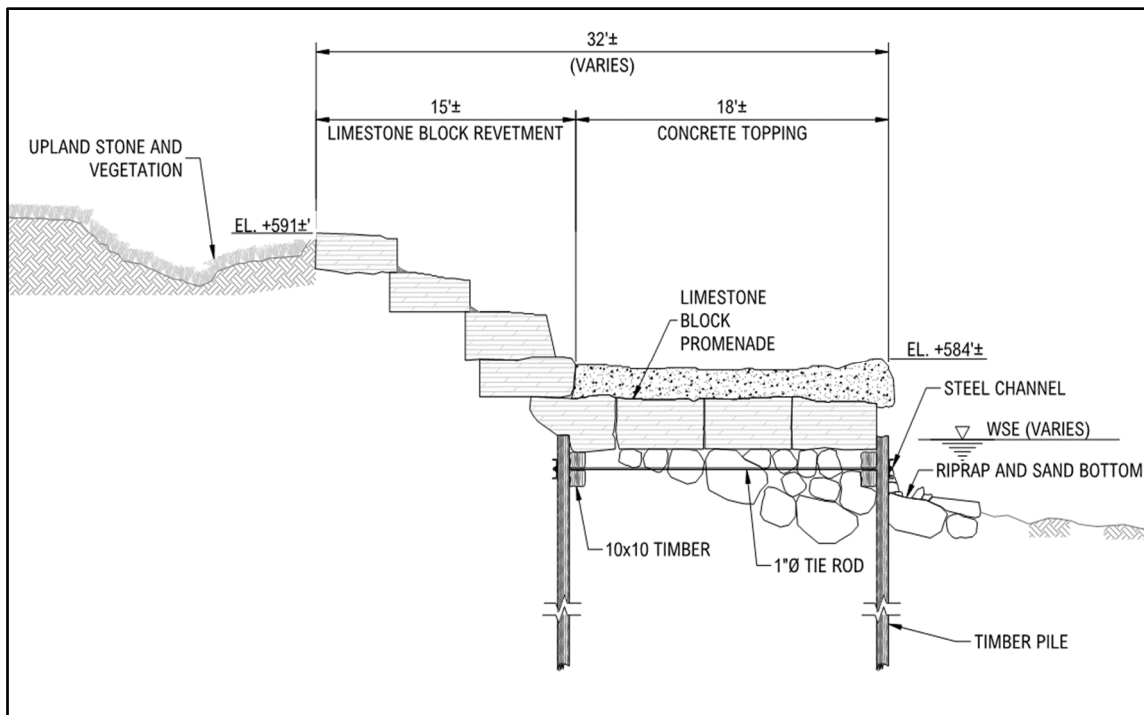
Figure 5.15. Typical Cross-Section of Section 5

Immediately offshore of the promenade, a row of timber piles supports the remains of a derelict cribbing system, including a failed steel waler and failed steel tieback rods. A typical cross section of S5 is provided below as **Figure 5.15**.

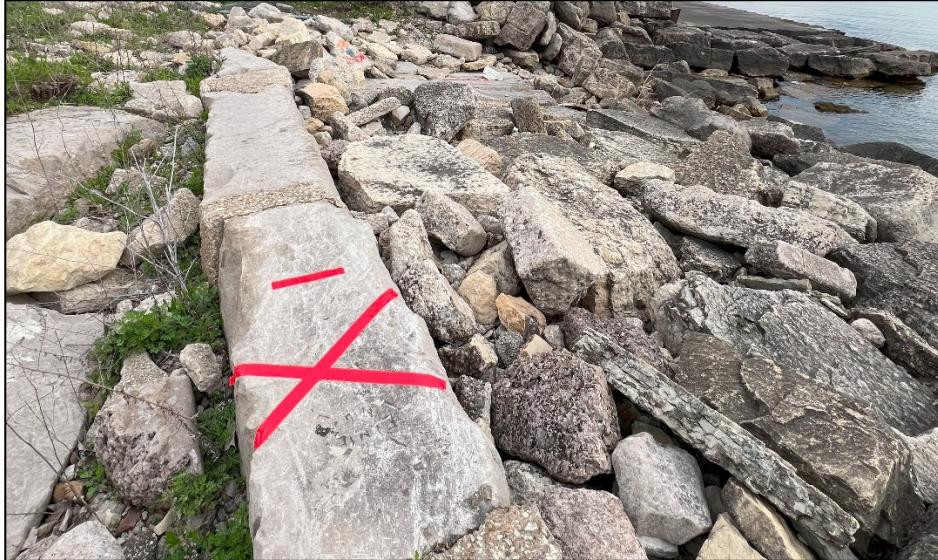
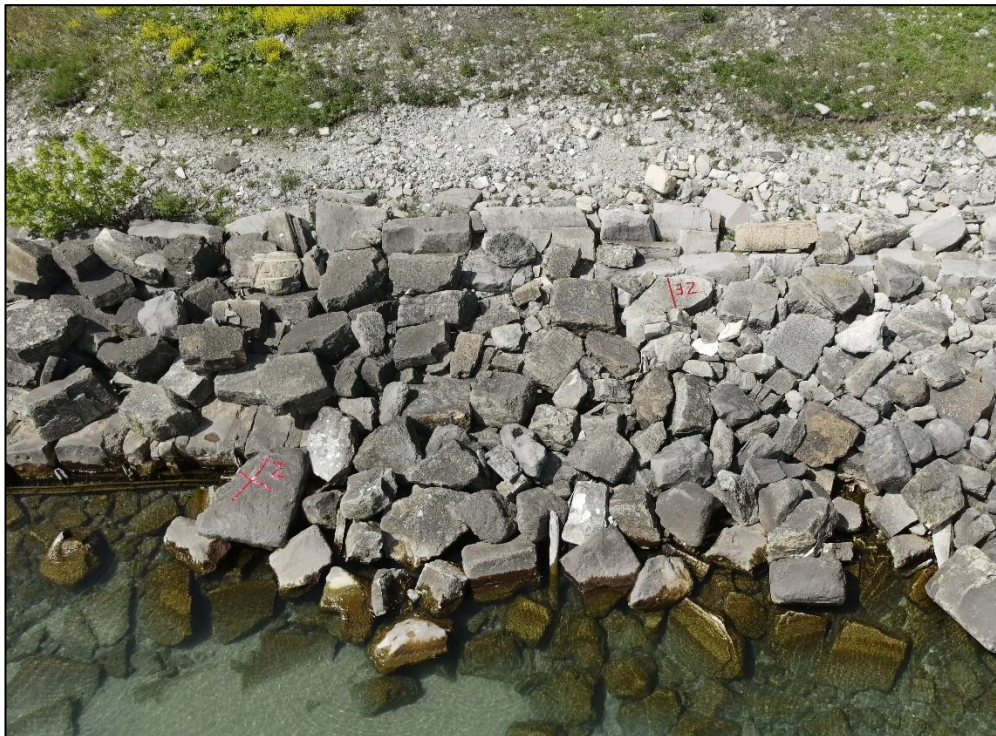
Figure 5.16. Terrestrial View of S6

Figure 5.17. Aerial View of S6

Section S6 is generally in fair condition and exhibits no significant deterioration. The upland exhibits erosion and rehabilitative efforts should be undertaken to provide additional drainage at this part of the site, however, there are no indications that S6 has suffered significant structural deterioration as a result of this erosion. From a purely structural perspective, there are no indications that restorative efforts are required for the promenade at S6. A typical cross section of S6 is provided as **Figure 5.18**.
