Chicago Stock Exchange Trading Room
Art Institute of Chicago
Chicago, Illinois 1977

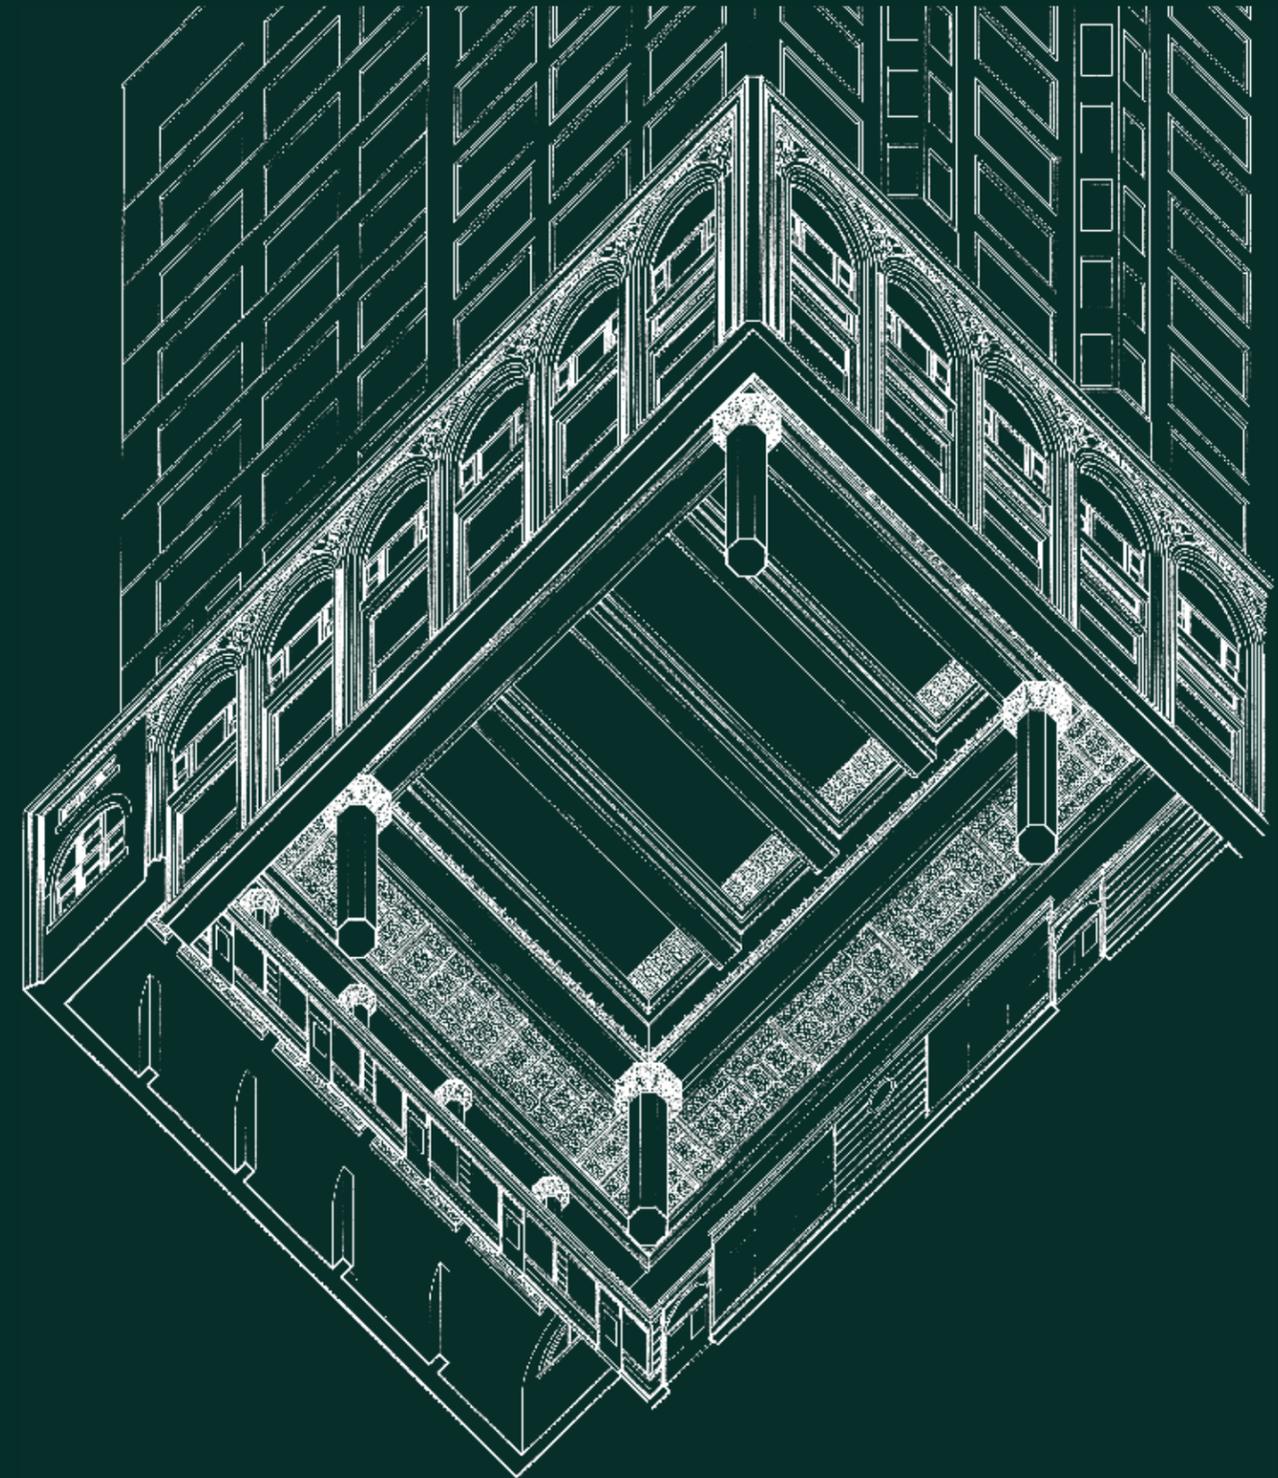
Above: Drawing by Lawrence Kenny showing the original orientation of the Trading Room.

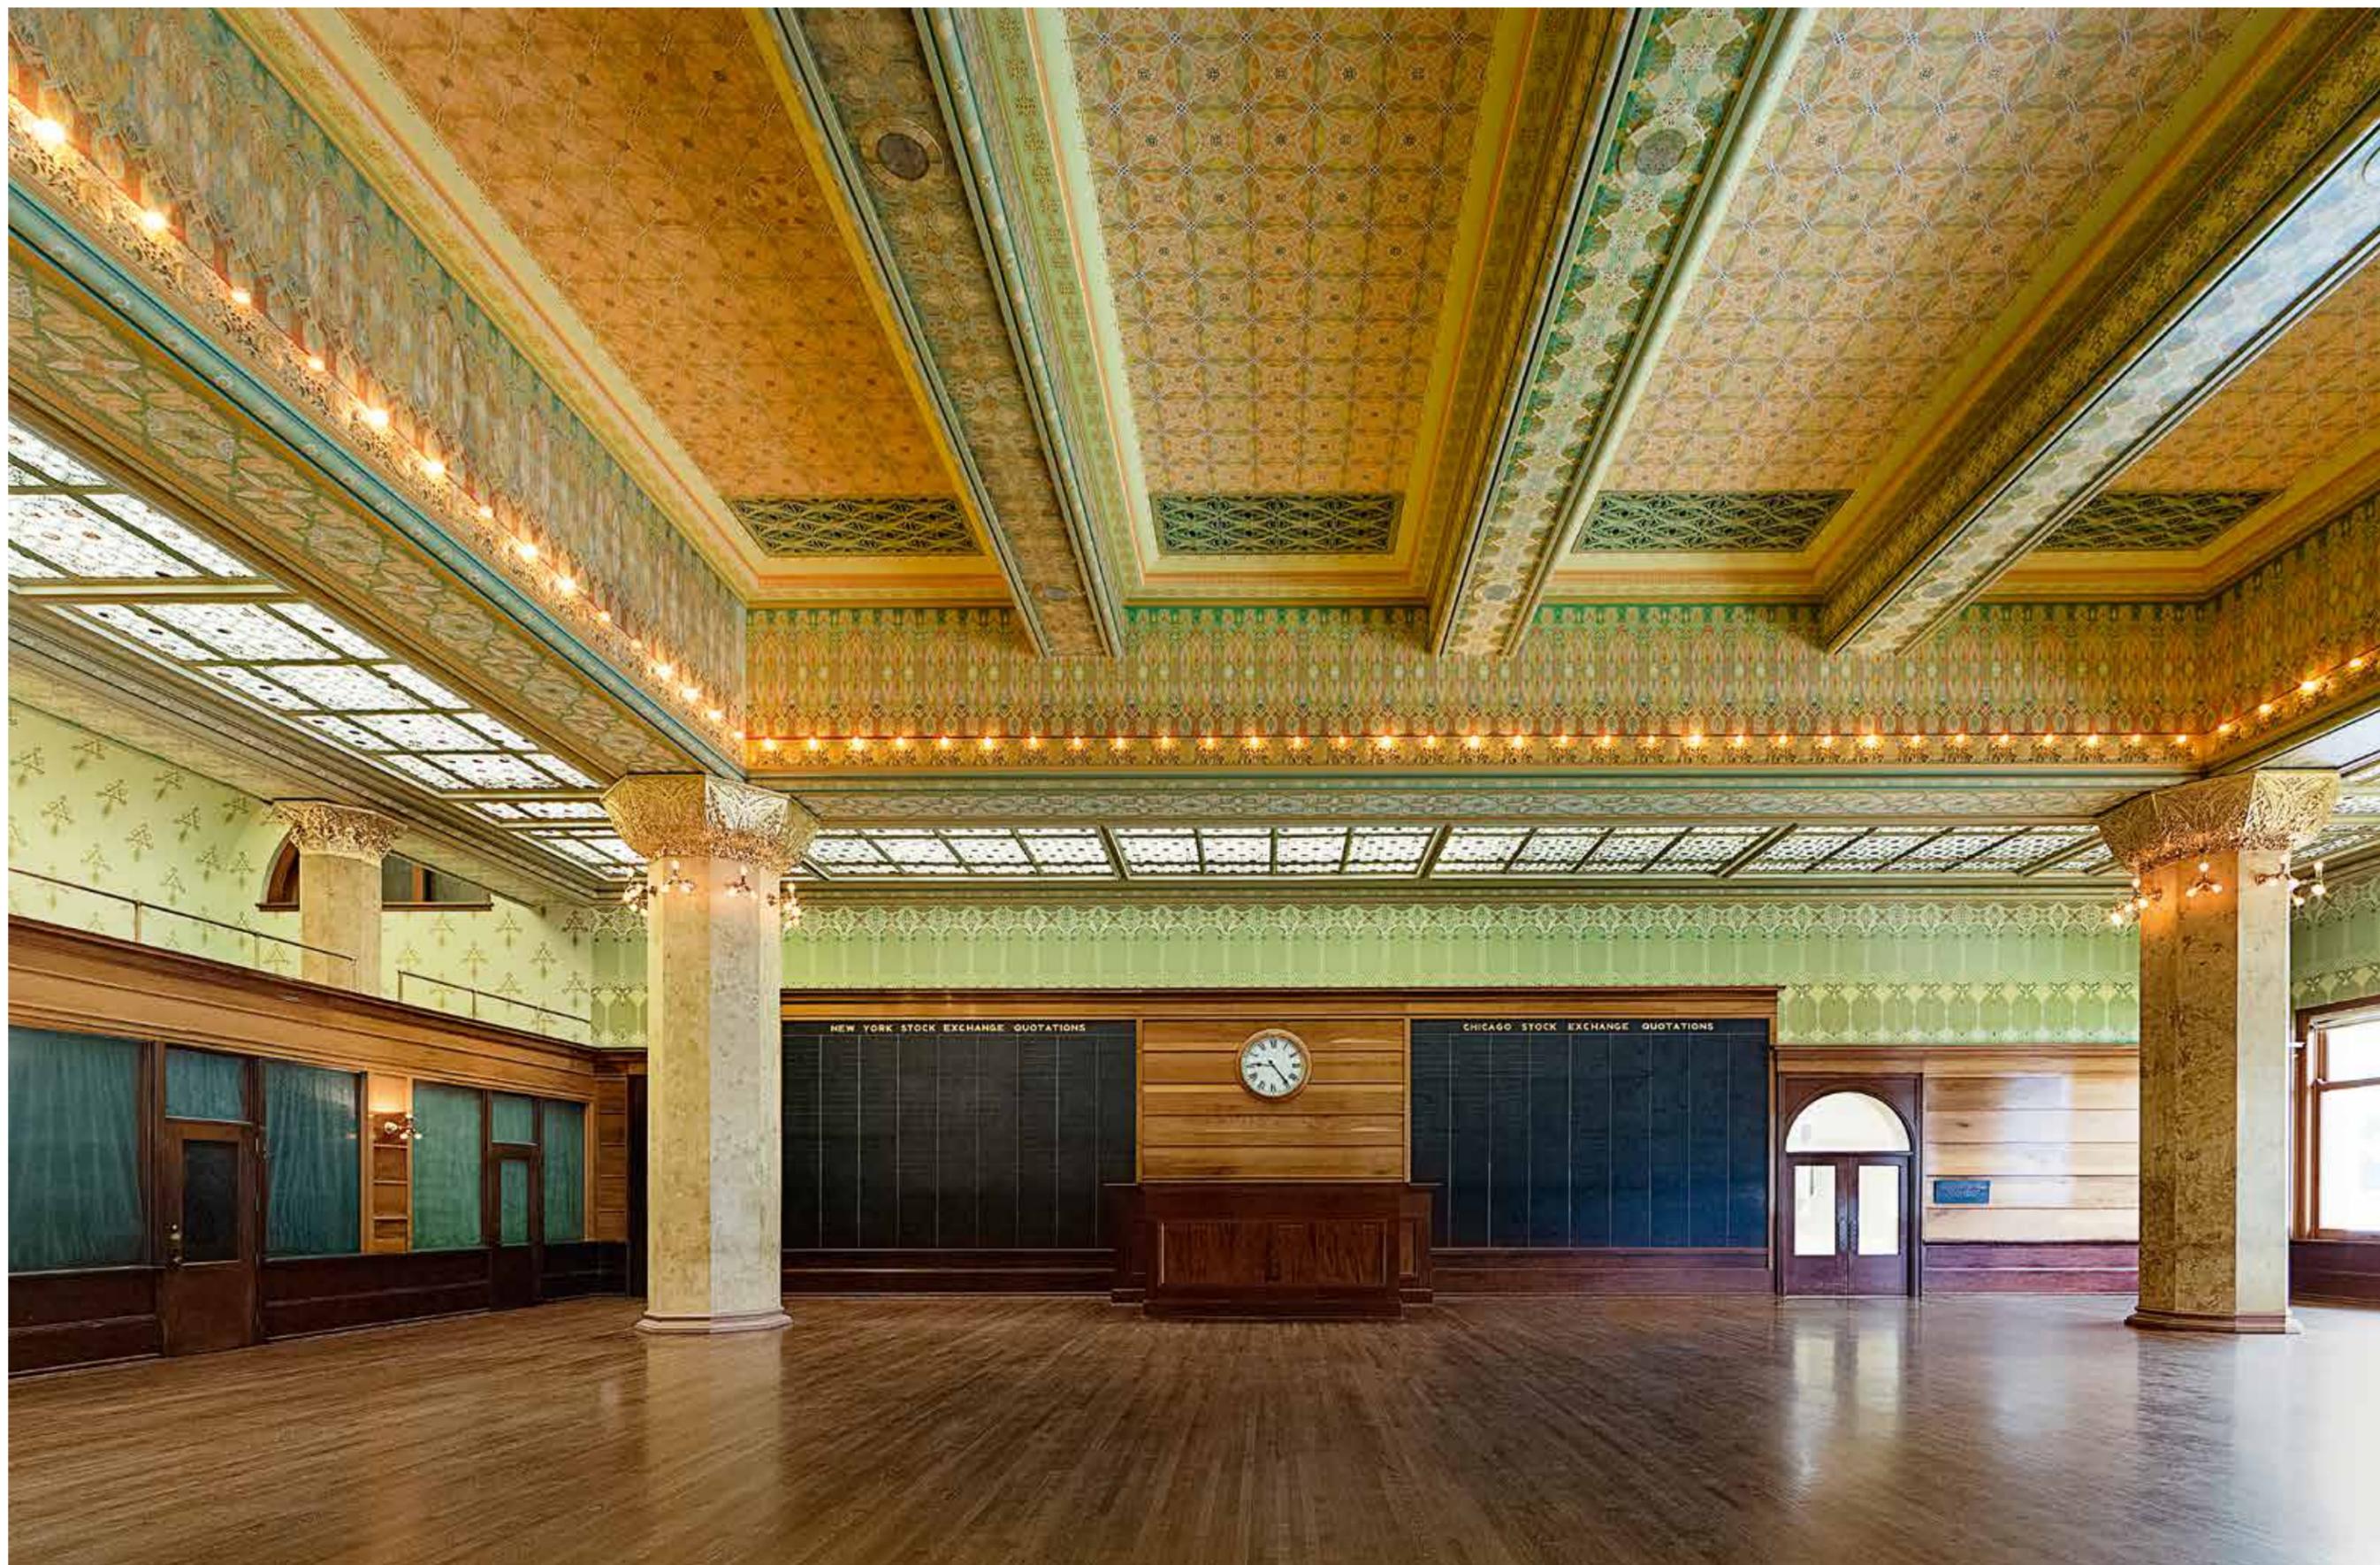
Previous spread: The re-created Chicago Stock Exchange Trading Room at the Art Institute of Chicago. The original elements consist of two column capitals, approximately two hundred art-glass skylights, and the far left bay of the ceiling.

The ceiling in particular is spectacular and also provides a side-by-side comparison with the original. Enough restorable ceiling canvas was saved to cover one of the four ceiling bays. The other three bays are reproductions, displaying the original unfaded colors.

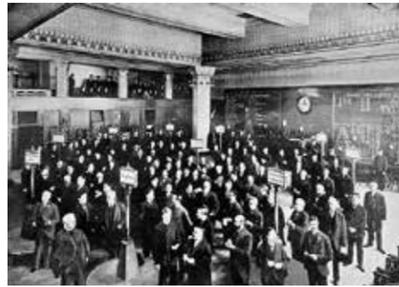
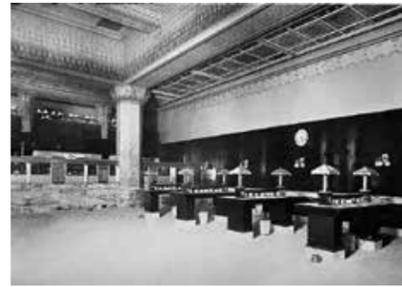
Above: Archival photos from before (left) and after (right) an early twentieth-century renovation project were used to re-create the Trading Room's original decorative scheme.

Most of what survived had been protected above a dropped ceiling. The rest – which included everything from the oak floor, mahogany paneling, and octagonal columns to the light fixtures, chalkboards, and clock – was missing altogether and had to be re-created using vintage photos and contemporary descriptions as starting points.

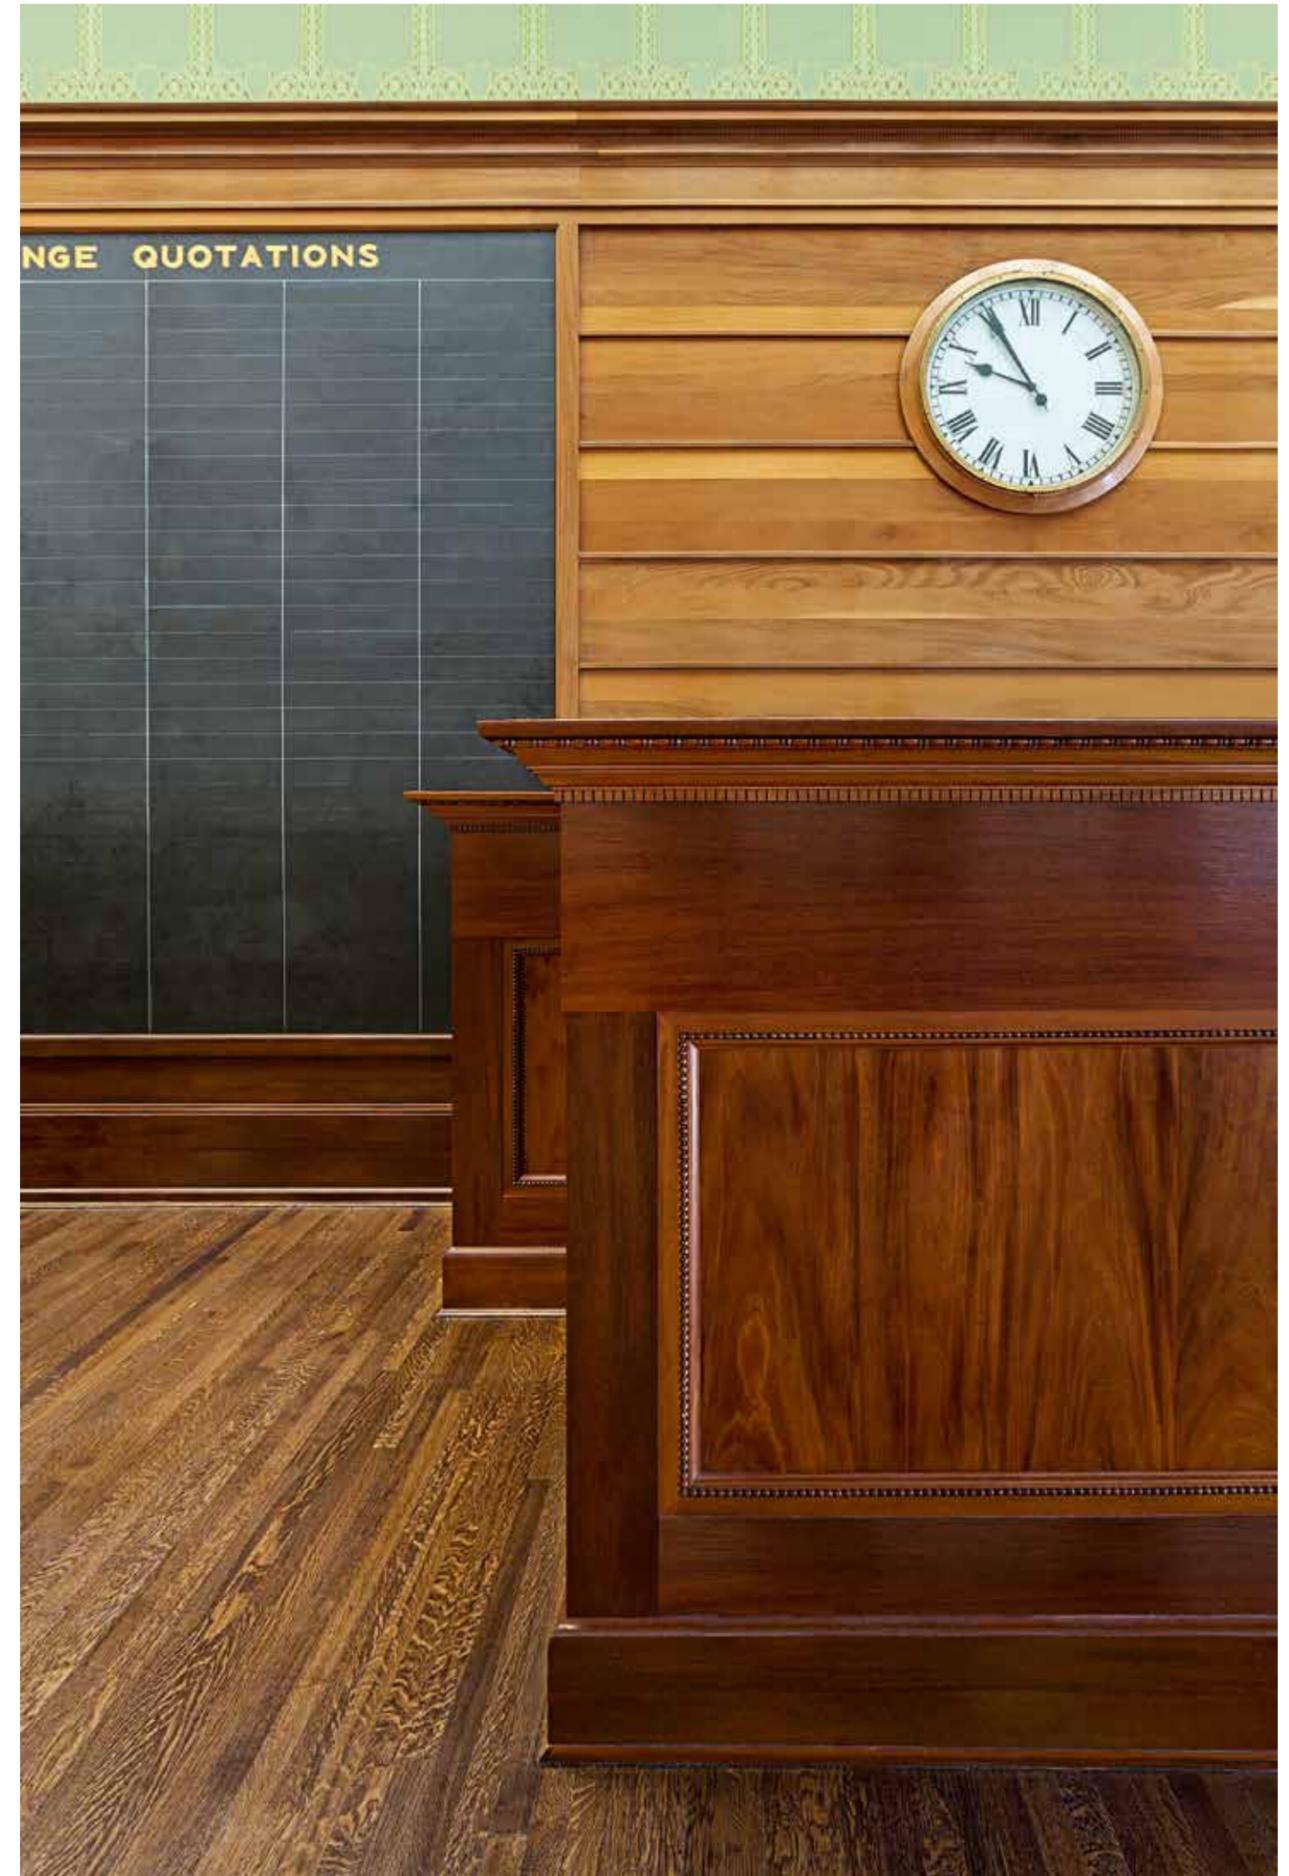
Right: The installation of the mahogany main desk in 1980 – three years after the room opened to the public – completed the Trading Room restoration project. No photos of the original desk were found, so Vinci based the design on a written description from the period.

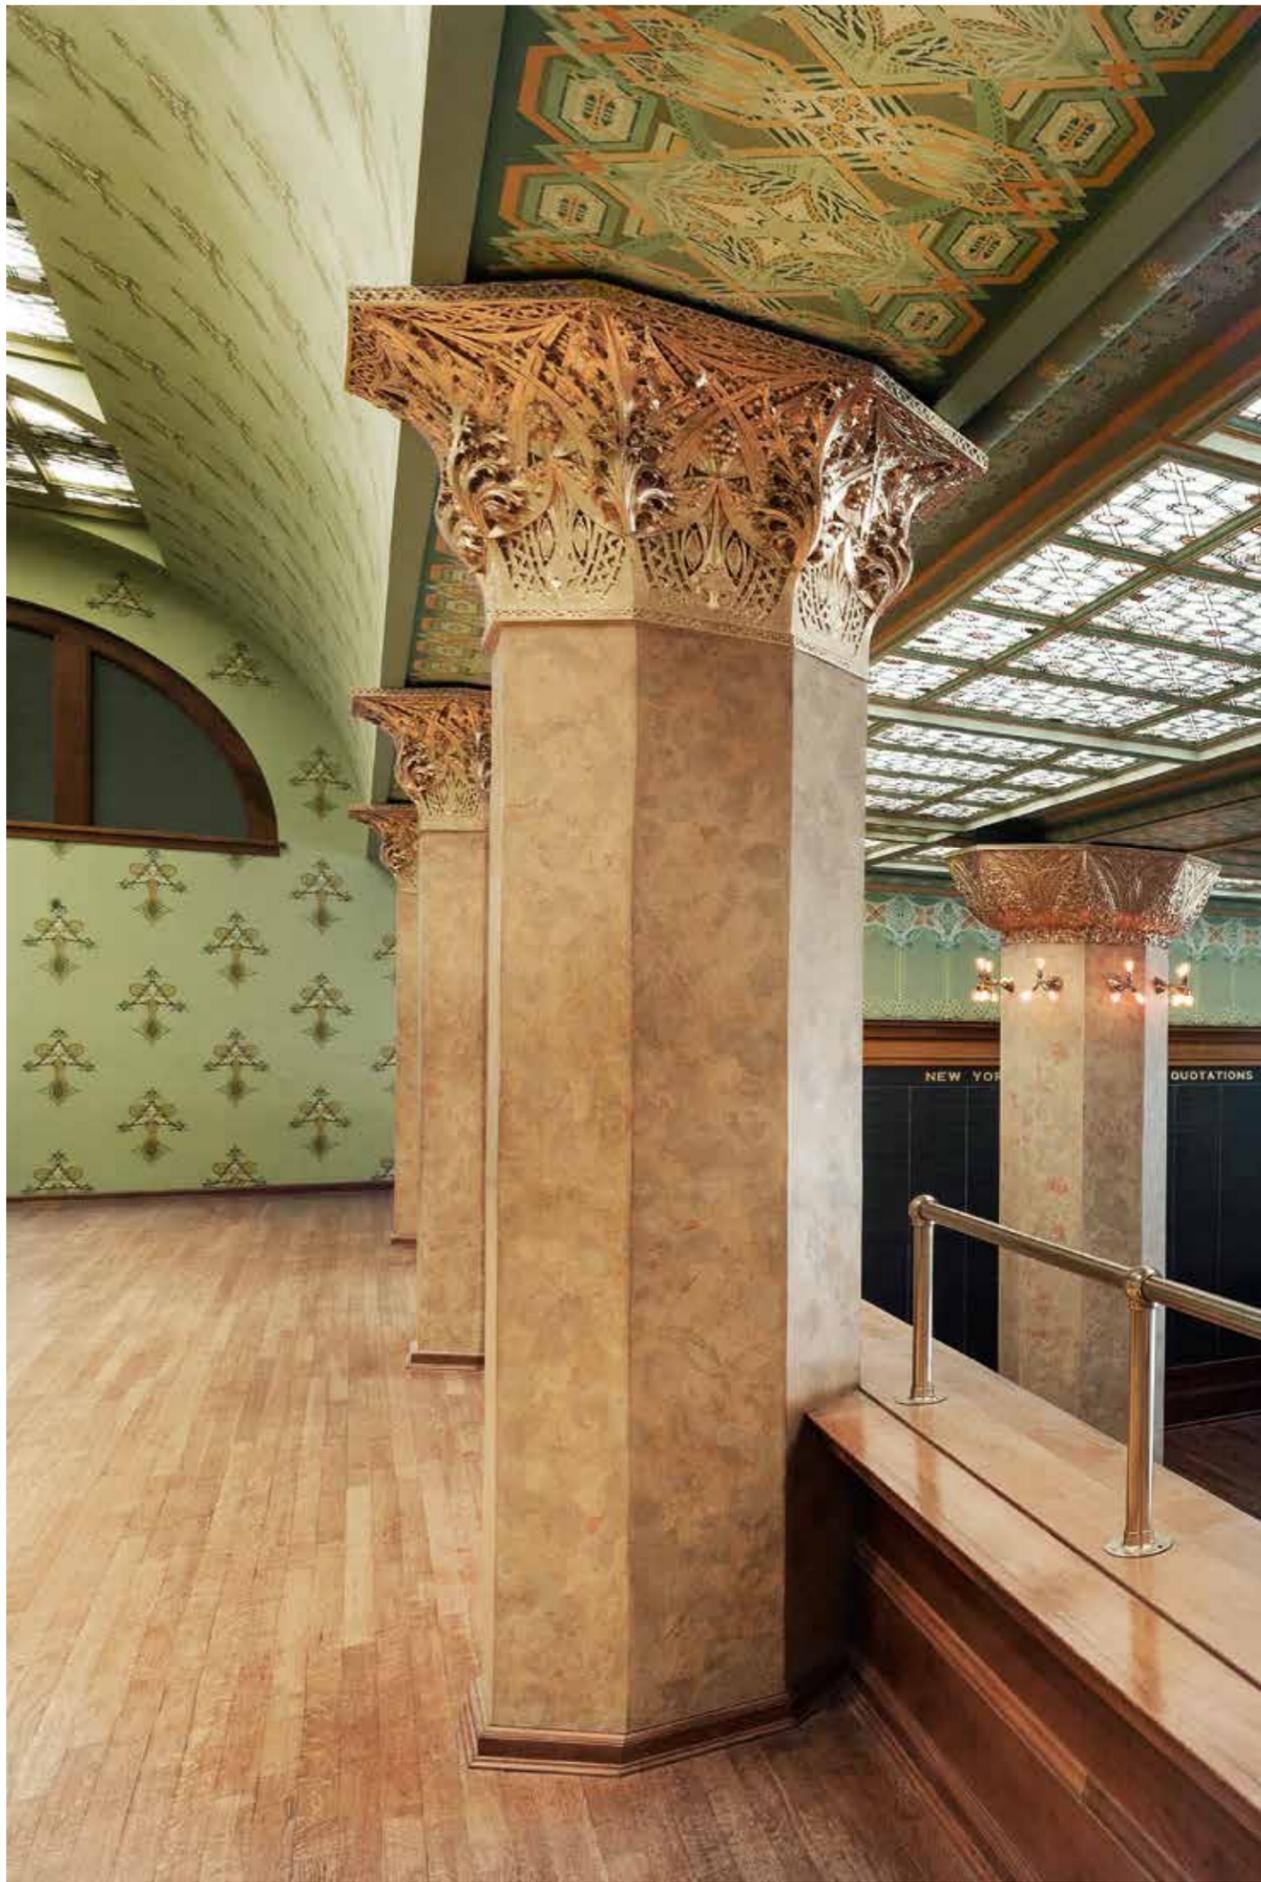
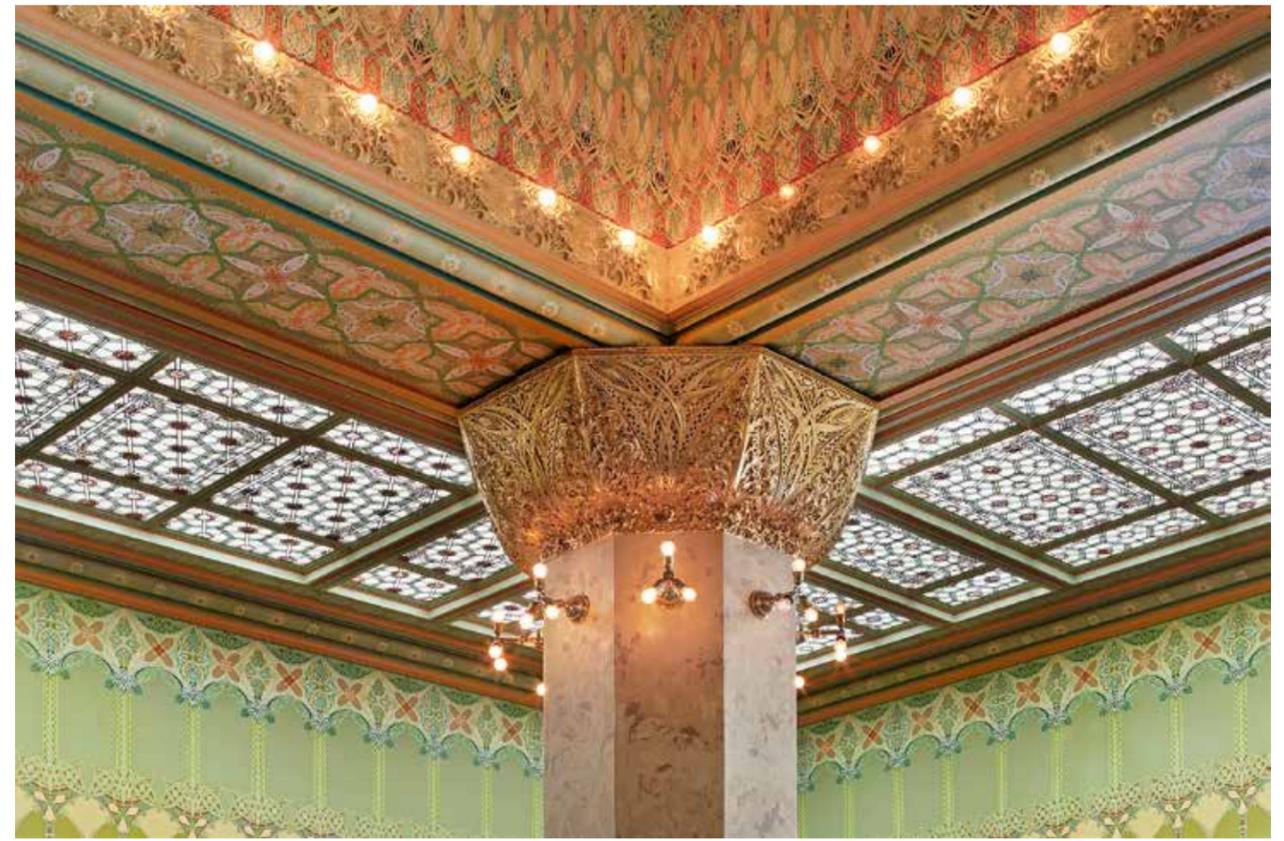
Left and above: Vinci used scagliola – a nineteenth-century plastering technique – to re-create the Trading Room's faux marble columns.

Re-creating the original decorative scheme also involved researching and relearning scagliola, a nineteenth-century plastering technique used to create various faux finishes. Here, it gives the room's four octagonal columns the appearance of being made of rare marble.

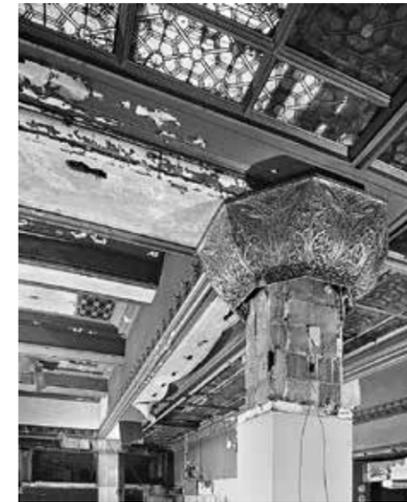
Right: The Trading Room's original elements were found above a dropped ceiling.

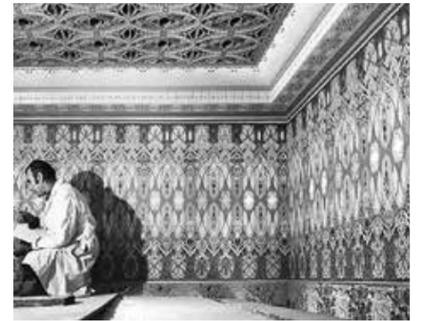
Far right: An unidentified artisan installs the re-created stencils, some of which had fifty-two colors.

One of the more complex patterns ultimately involved fifty-two different "cuts" or colors that had to be laid down sequentially in order to complete the design.

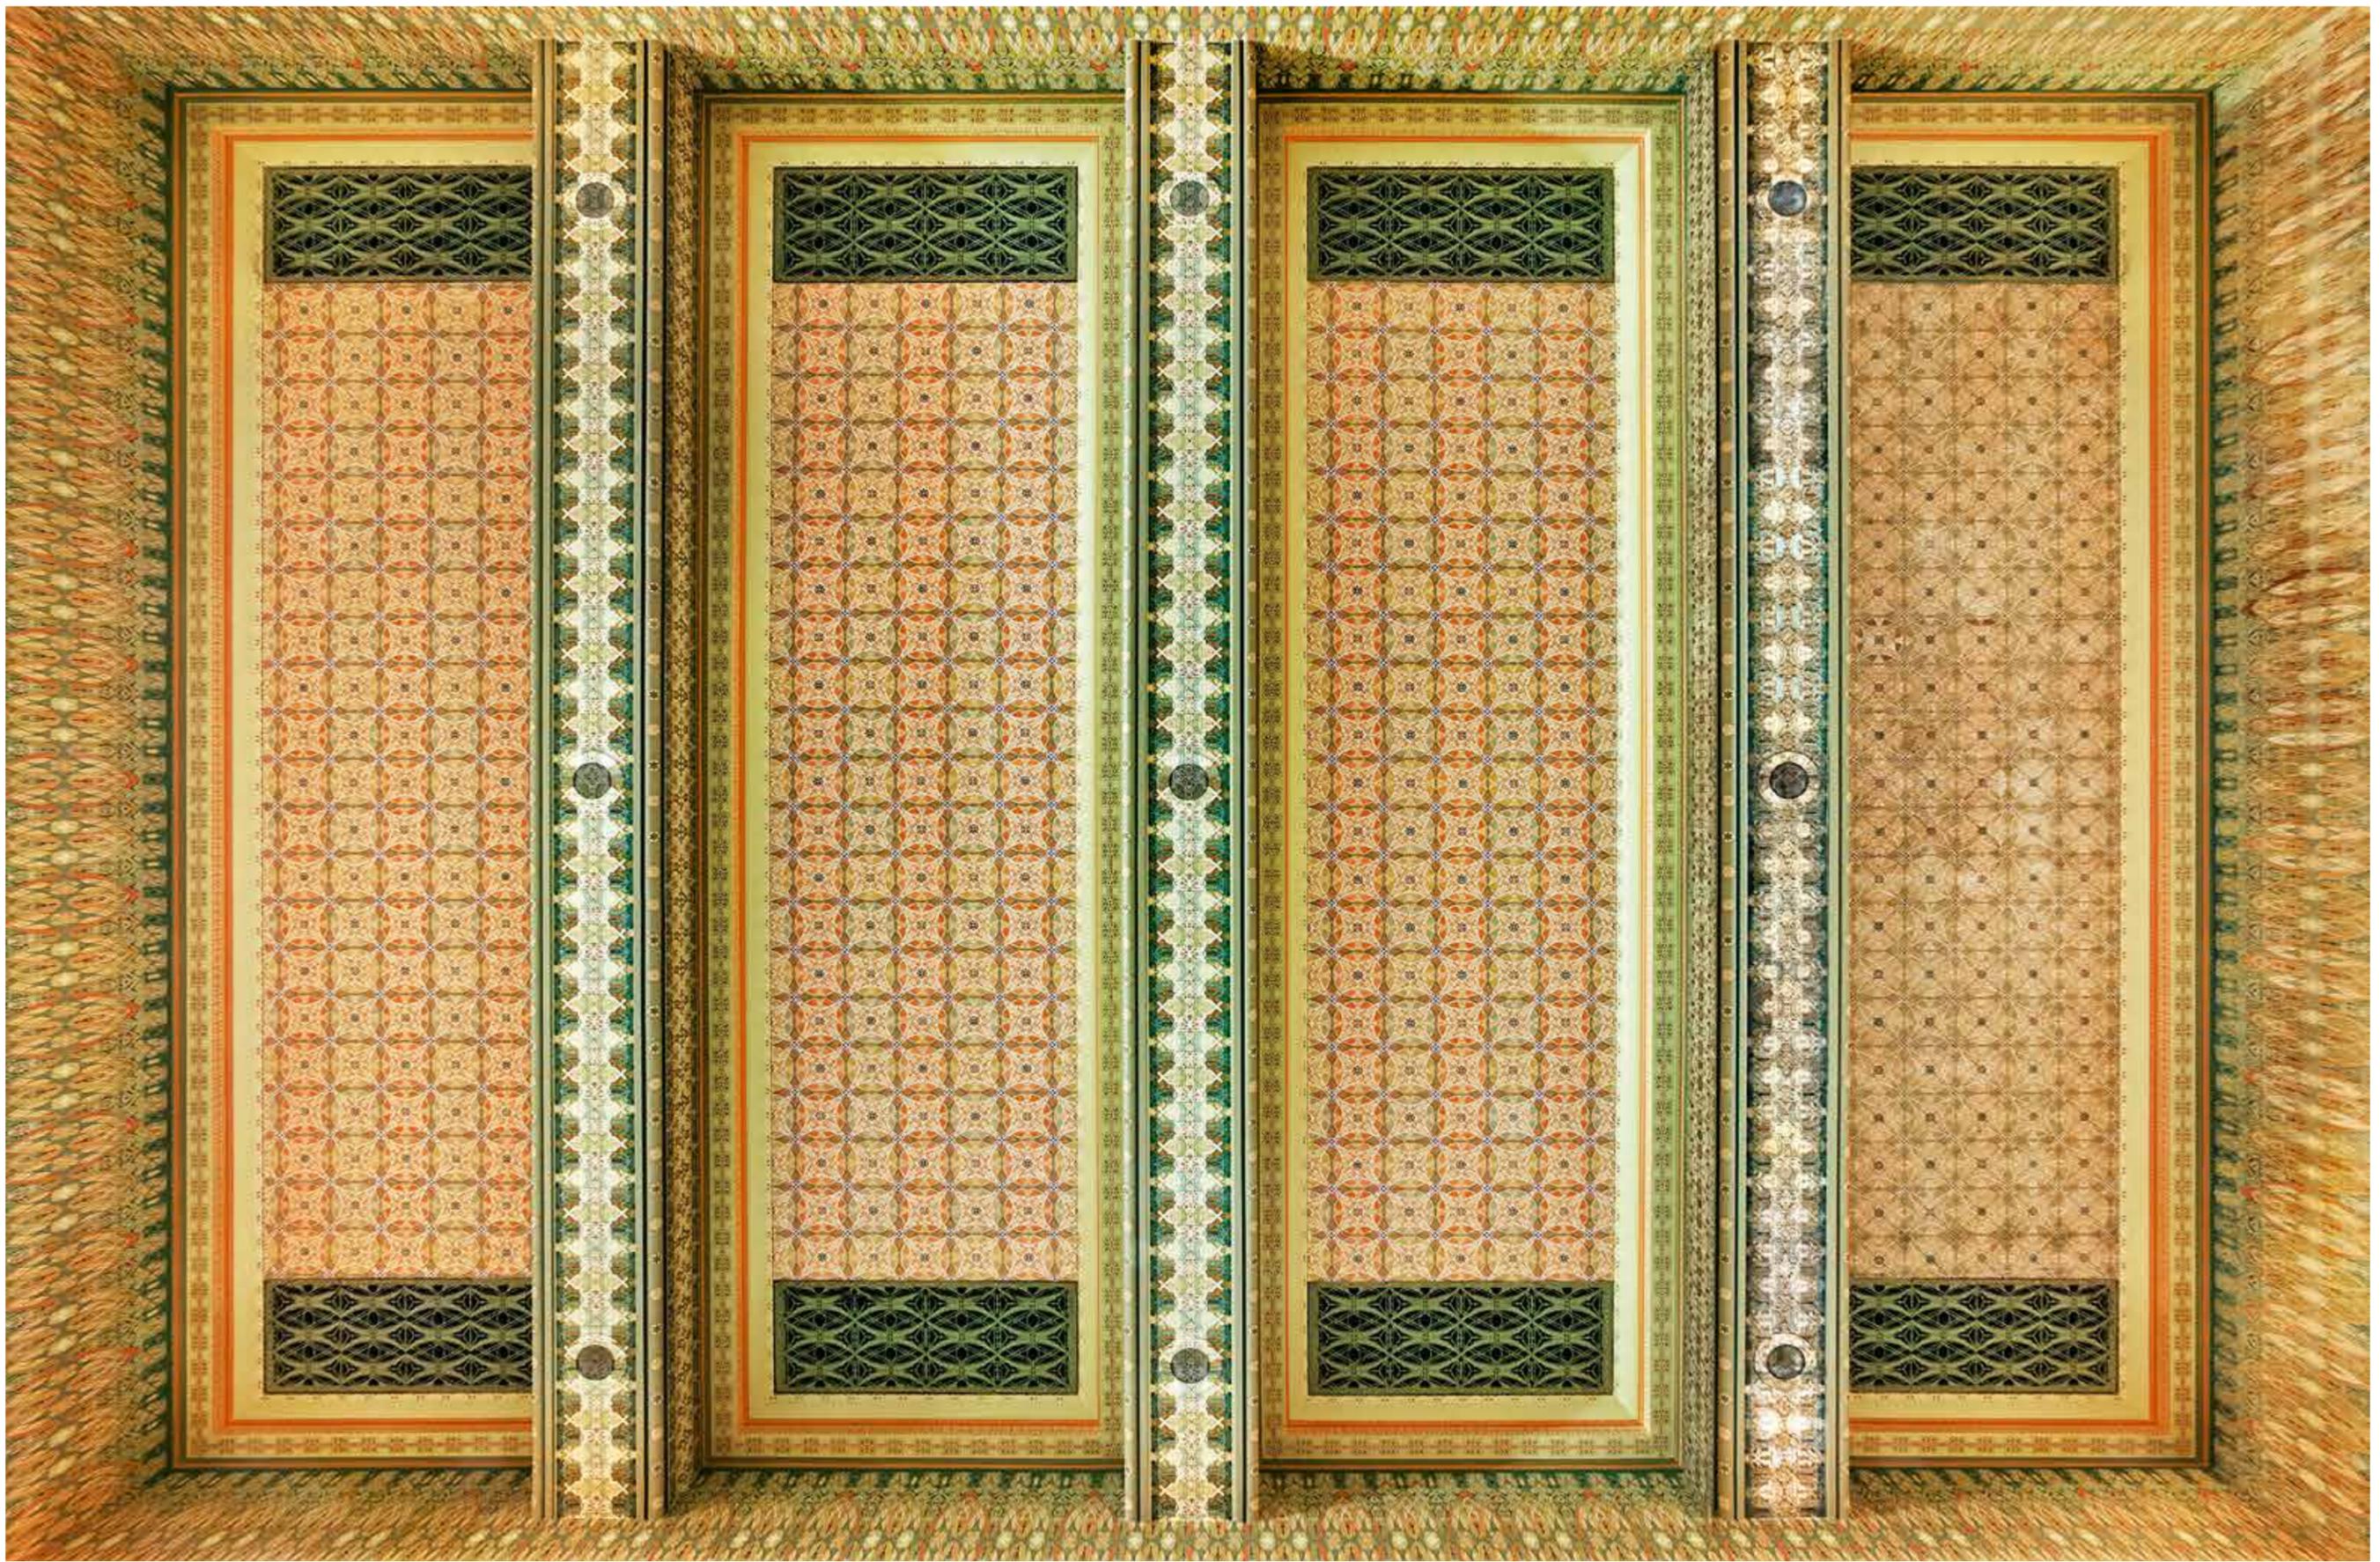
Above: The left three bays of the Trading Room's spectacular ceiling are re-creations while the darker far right panel was pieced together from original fragments.
