April 4, 2024

Re: Promontory Point Condition Study
5491 S DuSable Lake Shore Drive
Chicago, IL 60615

Executive Summary

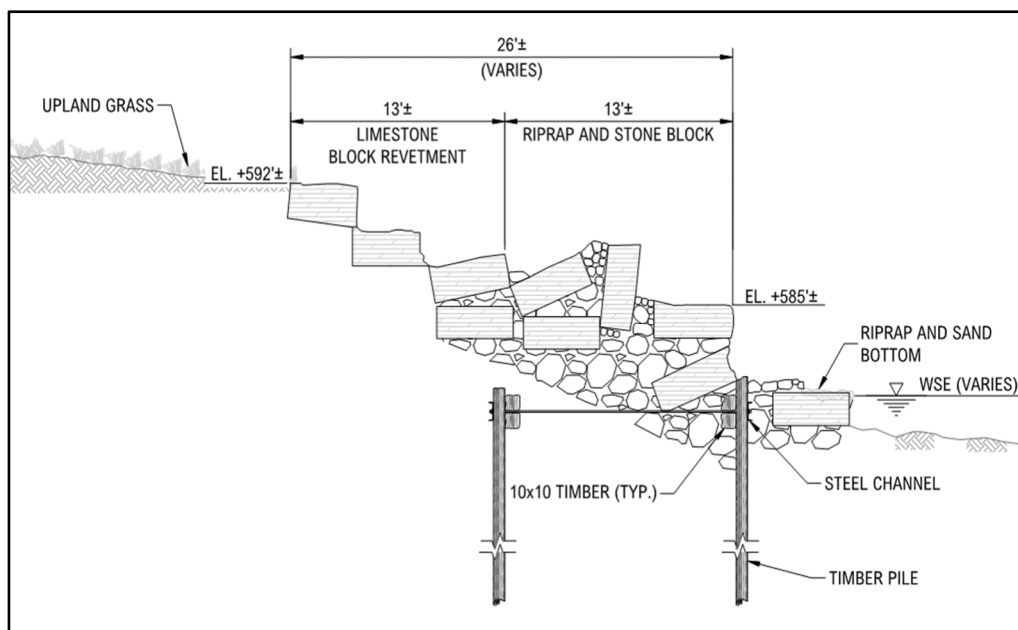
Figure 5.12. Typical Cross-Section of Section 4

S4 is generally in satisfactory condition and exhibits no significant deterioration. There is minor erosion present in the upland fill that may require additional drainage. The riprap promenade found here does not conform to the original, historic design of a stepped, limestone revetment down to a limestone promenade, having at some point replaced the initial structure after construction. This riprap promenade does not provide a universally accessible walkway to pedestrian visitors, an issue that should be re-visited, however, from a purely structural perspective, there are no indications that restorative efforts are required at S4.

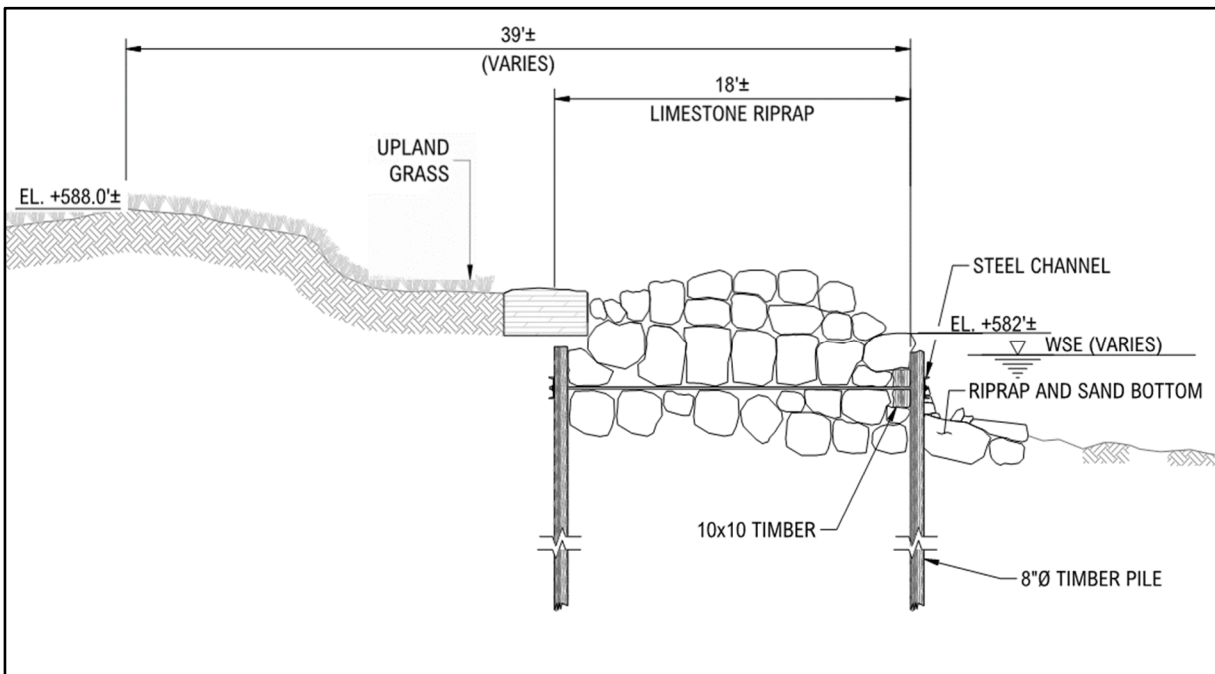
Figure 5.18. Typical Cross-Section of Section 6

S6 comprises limestone riprap with typical stone diameters between two (2) and four (4) feet. The stepped limestone revetment that is present throughout the Point does not extend to Section S6. The timber cribbing system has been partially covered by riprap. The timber pile remnants continue to support the toe of the riprap slope, resisting lateral movement.

Section S6 is generally in fair condition and exhibits no significant deterioration. The upland exhibits erosion and rehabilitative efforts should be undertaken to provide additional drainage at this part of the site, however, there are no indications that S6 has suffered significant structural deterioration as a result of this erosion. From a purely structural perspective, there are no indications that restorative efforts are required for the promenade at S6. A typical cross section of S6 is provided as **Figure 5.18**.
